### Inspection Report

#### Minerals Regulatory Program

**Mine Name:** Lisbon Valley  
**Operator Name:** Lisbon Valley Mining Company

**Permit number:** M/037/0088  
**Inspection Date:** August 26, 2009  
**Time:** 1:00-4:00 PM

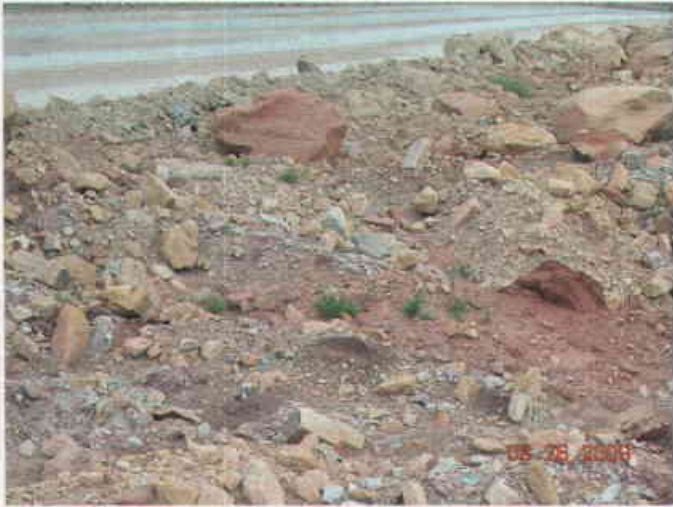
The operator seeded several areas last year, and we looked at some of these to see how successful revegetation efforts have been. The road between the county road and waste dump B was roughened and seeded, and the operator has now re-established a road across this area. The road is narrower than the old road, so the sides and outcrops have not been re-disturbed. The entire area was nicely roughened. Portions of these areas have sandstone-derived growth media, and parts have more shale and clay. The

areas with sandstone have a moderate amount of grass and fourwing saltbush, but the areas with shale and clay have little vegetation. There are not a lot of weeds, but there is some Russian thistle.

**Photo 1.** Vegetation next to the haul road between waste dump B and the county road.

The operator may want to consider re-seeding the sides of the haul road between the county road and waste dump B. While there is some desirable vegetation in this area, it is limited. If the area is re-seeded, I suggest doing it at a reduced rate and possibly annually for a few years.

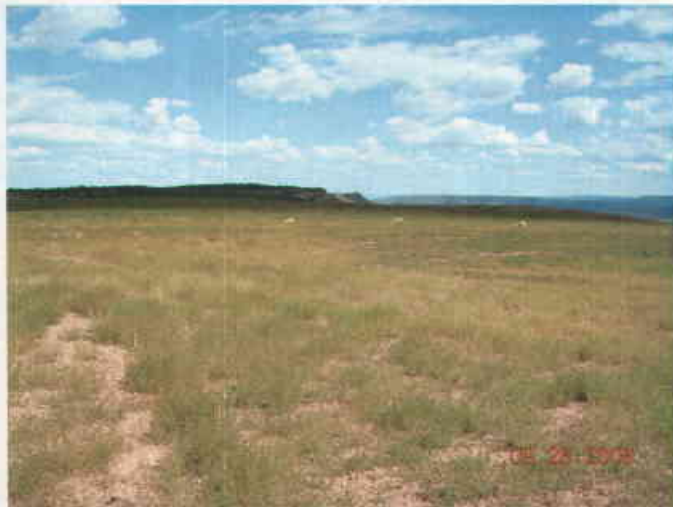
Soil was spread on top of waste dump C and this area was seeded last fall. This entire area is covered with a lot of Russian thistle, but on close examination, there are also a lot of grass seedlings. Many of these seedlings are dry and may be dead, but many are still alive.

**Photo 2.** The top of waste dump C. There is a lot of Russian thistle.

The operator was considering re-seeding the top of waste dump C, but I recommend waiting at least a year to evaluate the success of last year's seeding.

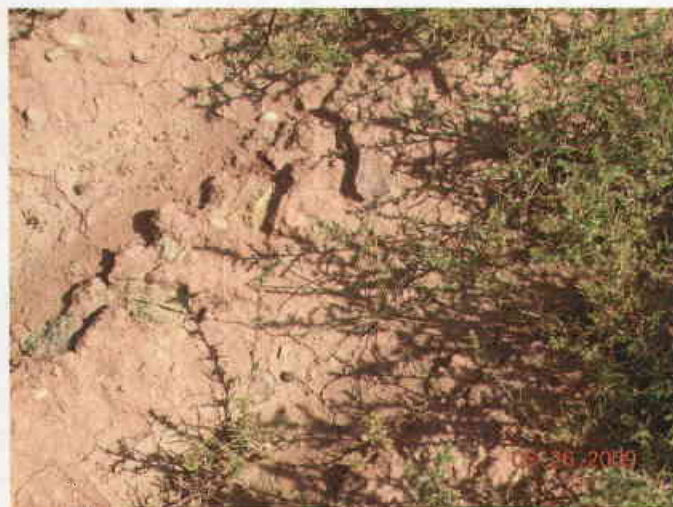
**Photo 3.** Among the Russian thistle on the top of waste dump C there is a fair amount of grass (which is difficult to see).

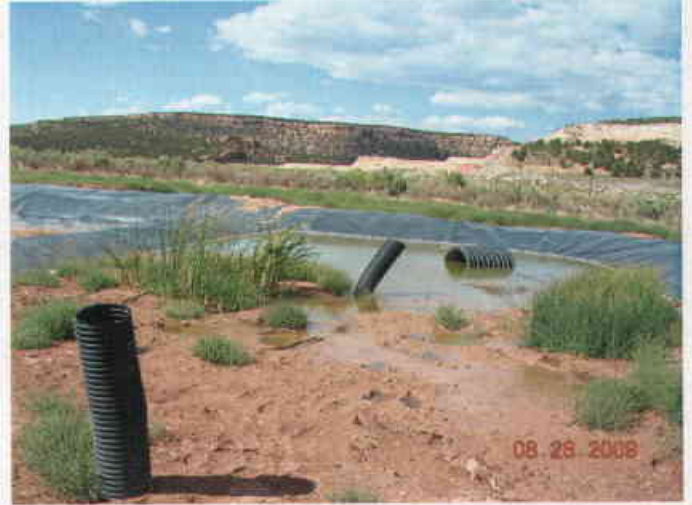
We also looked at the wetland that was built to treat water coming from the maintenance shop and adjacent areas. Mr. Indergard had planted a bunch of coyote willows, but they have all died. There may have been too much water for the willows. Most of the remaining vegetation is cattails and bulrushes, but there is a little Kentucky bluegrass.

**Photo 4.** The small wetland that was built to treat waste water from the shop and other adjacent buildings.

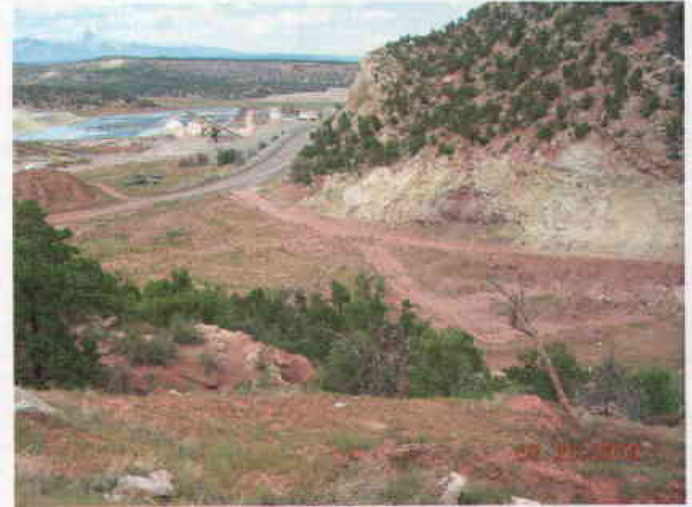
The operator would like to build a new road from the GTO Pit to the leach pad. The road would run next to the water tank and would greatly shorten the haul distance. There is a draw on the north side of the water tank in which the operator could place waste material and lessen the grade. The operator needs to submit an amendment to show this haul road and the waste that would be placed in the draw.

**Photo 5.** The draw below the water tank where the operator is considering placing a new haul road from the GTO Pit to the leach pad.

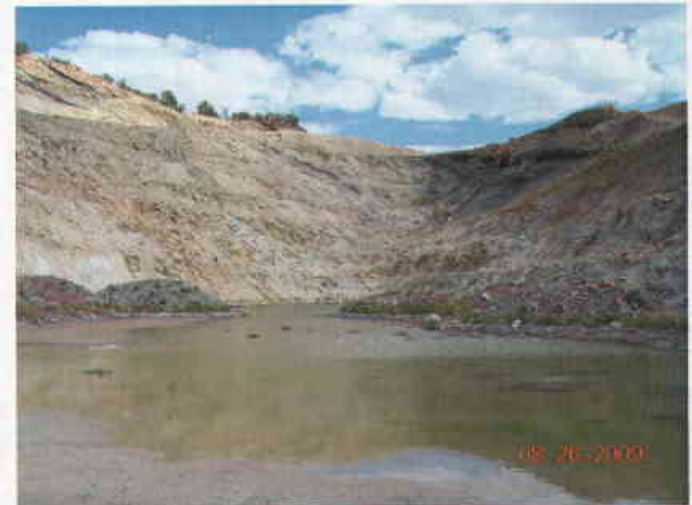
We went to the bottom of the Sentinel West Pit to see the pond that has developed. We also went to the GTO Pit to see the results of a blast that was done about the time I arrived at the site. The operator is trying to use blasting to break up the ore because the crushers are not being used.

**Photo 6.** The pond at the bottom of the Sentinel West Pit.
